MOUNTAIN SPRINGS LAKE DAM

NDI ID NO. PA-00770
DER ID NO. 45-42

PHASE I INSPECTION REPORT
NATIONAL DAM INSPECTION PROGRAM

JANUARY 1980

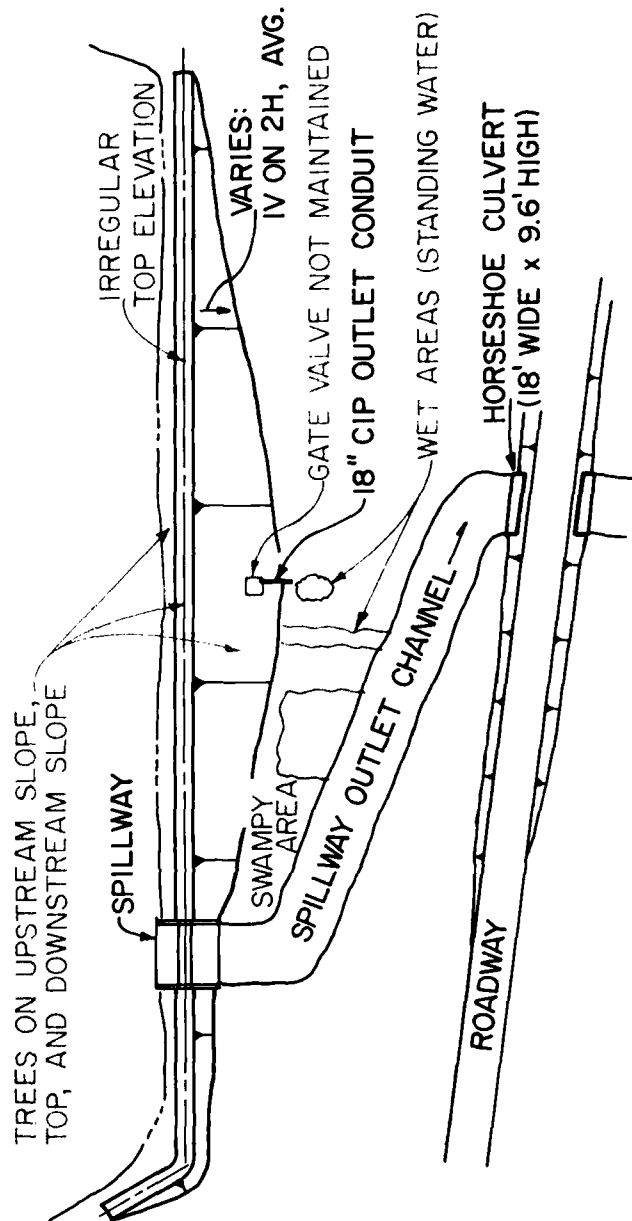
PLAN - DAM
NOT TO SCALE

b. Dam and Dike. Most of the upstream slope of the dam was submerged and could not be surveyed or inspected. The riprap appears to be in good condition. It extends to the top of the dam. The upstream slope, top, and downstream slope are overgrown with trees having an average diameter of 4 to 6 inches (Photographs A and B). Except for the trees, the downstream slope of the embankment is in satisfactory condition. Two wet areas were observed at the toe of the dam. Although standing water was present, no flow was visible. A large swampy area, which did not have significant amounts of standing water, was also located in the area downstream from the toe of the dam. The approximate locations and extents of the wet areas and the swampy area are shown on Exhibit B-1.

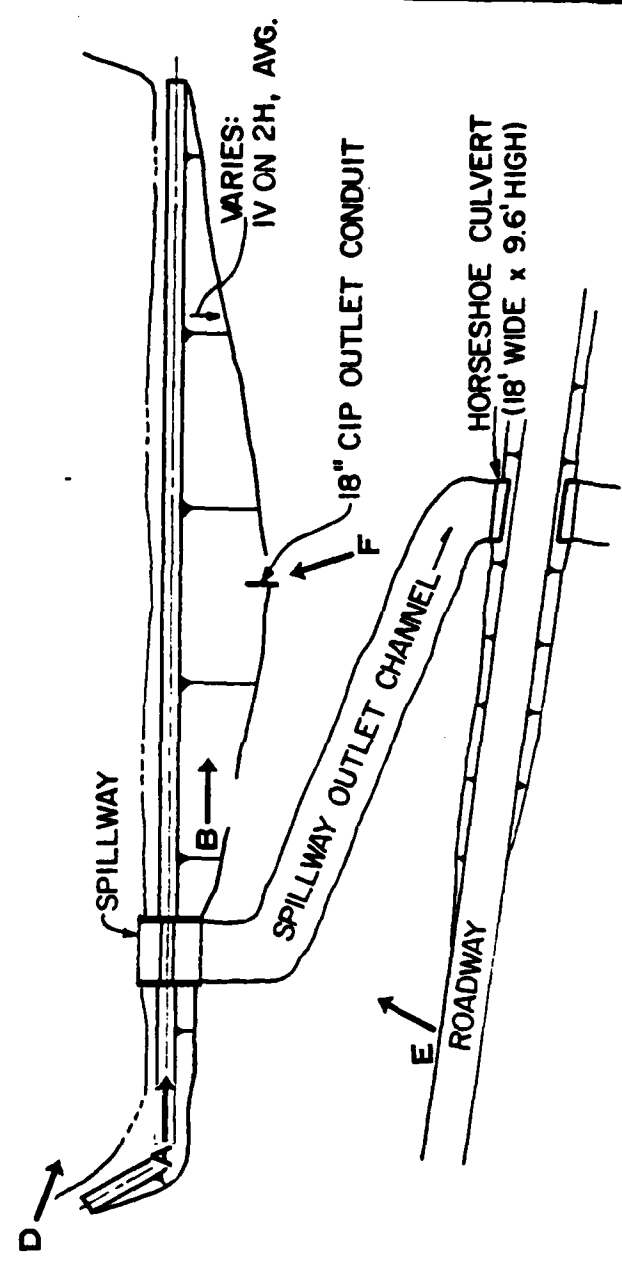
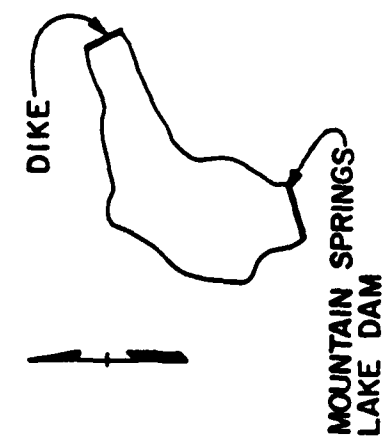
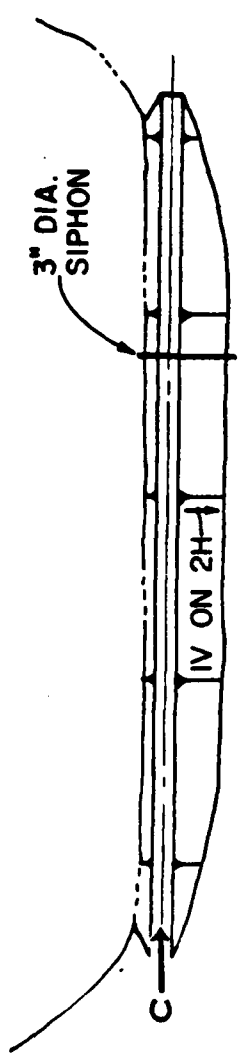
PHASE I INSPECTION REPORT
NATIONAL DAM INSPECTION PROGRAM
MOUNTAIN SPRINGS LAKE DAM
JACK B. RADER
RESULTS OF
VISUAL INSPECTION

a. General. The overall appearance of the dam is fair, with some deficiencies as noted herein. The locations of deficiencies are shown on Exhibit B-1 in Appendix B. Survey data acquired during this inspection are presented on Plates E-2 and E-3. On the day of the inspection, the pool was 0.2 foot above the spillway crest elevation.
